Diversified Power, Inc.

Off-Road Haul Truck Condition Report

Inspection Date 11/4/2009		Equipment # MC853
Make: Komatsu	Model: HM300-1	Year: Mileage: 26,475
Type of Equip.: off road dump	Hour Meter: 5721	Serial # KMTHM001E26001318
Ratings are : Not Applicable, Excellent, Good, Satisfactory, Fair, Poor		Comments
Overall Appearance:	Satisfactory	
Operating Condition:	Satisfactory	Operator display has several codes on screen.
Engine:		Fuel system on engine leaks down. Engine runs normally, hard to start initially. Fuel system must be primed before engine will start. Engine model SAA6D125E-3
Run/Start:	yes	
Brand:	Komatsu	
Liters:		
Horsepower:	335	
Battery:	Fair	
Oil leaks:	yes	
Engine Brake:	n/a	
Cab Interior:		
Interior:	Satisfactory	
Air Conditioner:	Satisfactory	
Seat:	Satisfactory	
Heater:	Satisfactory	
Air Ride Cab:	n/a	
Tilt Wheel:	Satisfactory	
Truck:		Exhaust pipe top rusted through. Brakes operate normally. Planetary seal leak on middle axle on left side. Fender flares on both sides broken. Hydraulic level low.

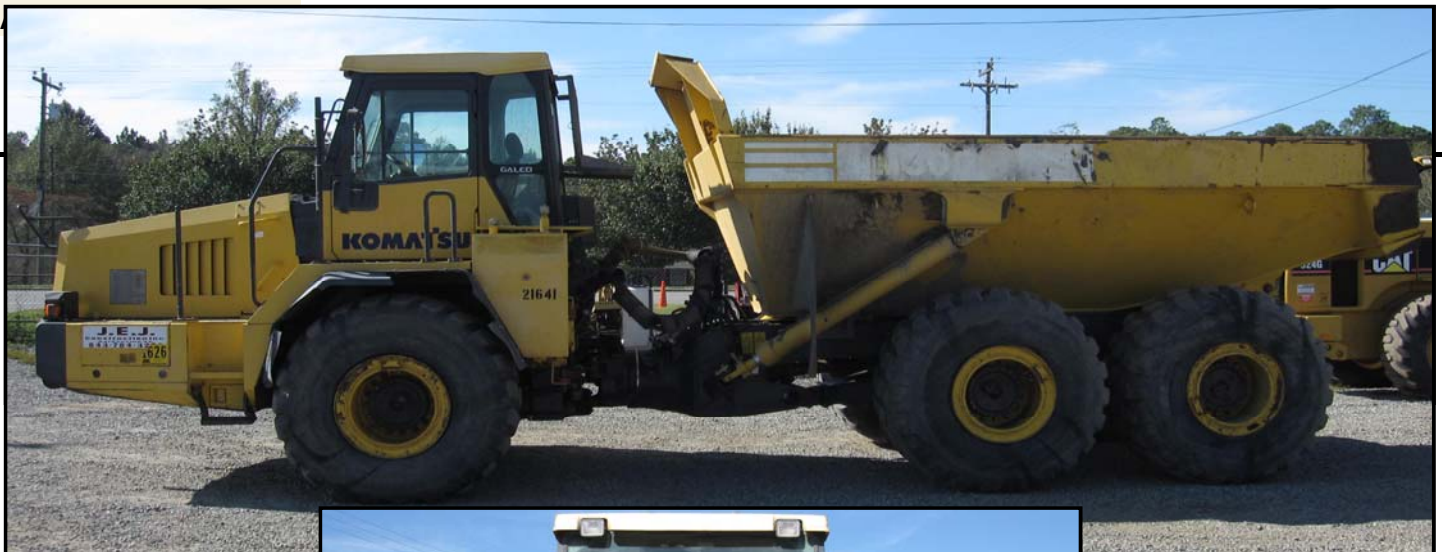
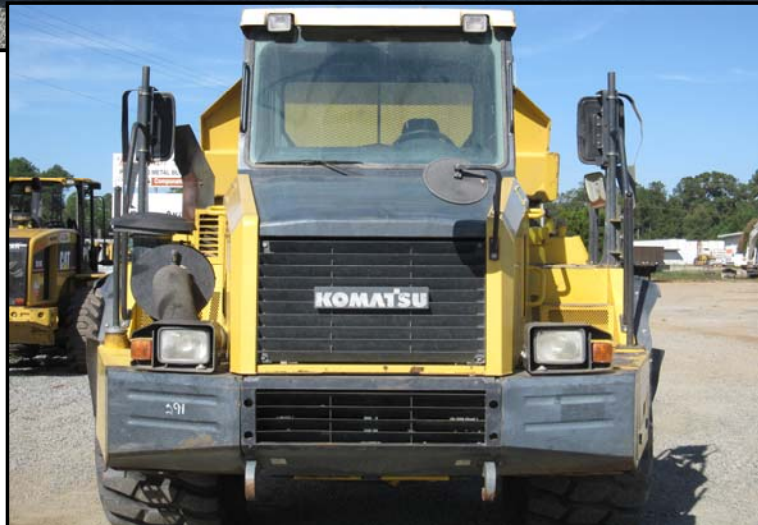
Inspection Date	11/4/2009	Equipment #	MC853	
Make:	Komatsu	Model:	HM300-1	Year: 0 Mileage: 26475	
Type of Equip.:	off road dump	Hour Meter:	5721	VIN: KMTHM001E26001318	
1st Axle:	*Percentages are left side then right side. All tires weathercracked.				
Tire Size:					750/65R25
Condition:					Satisfactory
Tire %:					60%
2nd Axle:	Small cuts in LH sidewall.				
Tire Size:					750/65R25
Condition:					Satisfactory
Tire %:					60%
3rd Axle:	Small cuts in LH and RH sidewall.				
Tire Size:					750/65R25
Condition:					Satisfactory
Tire %:					60%
